REPORT OF APOLLO 13 REVIEW BOARD

**APPENDIX B - REPORT OF MISSION
EVENTS PANEL**

**APPENDIX C - REPORT OF MANUFACTURING
AND TEST PANEL**

APPENDIX D - REPORT OF DESIGN PANEL

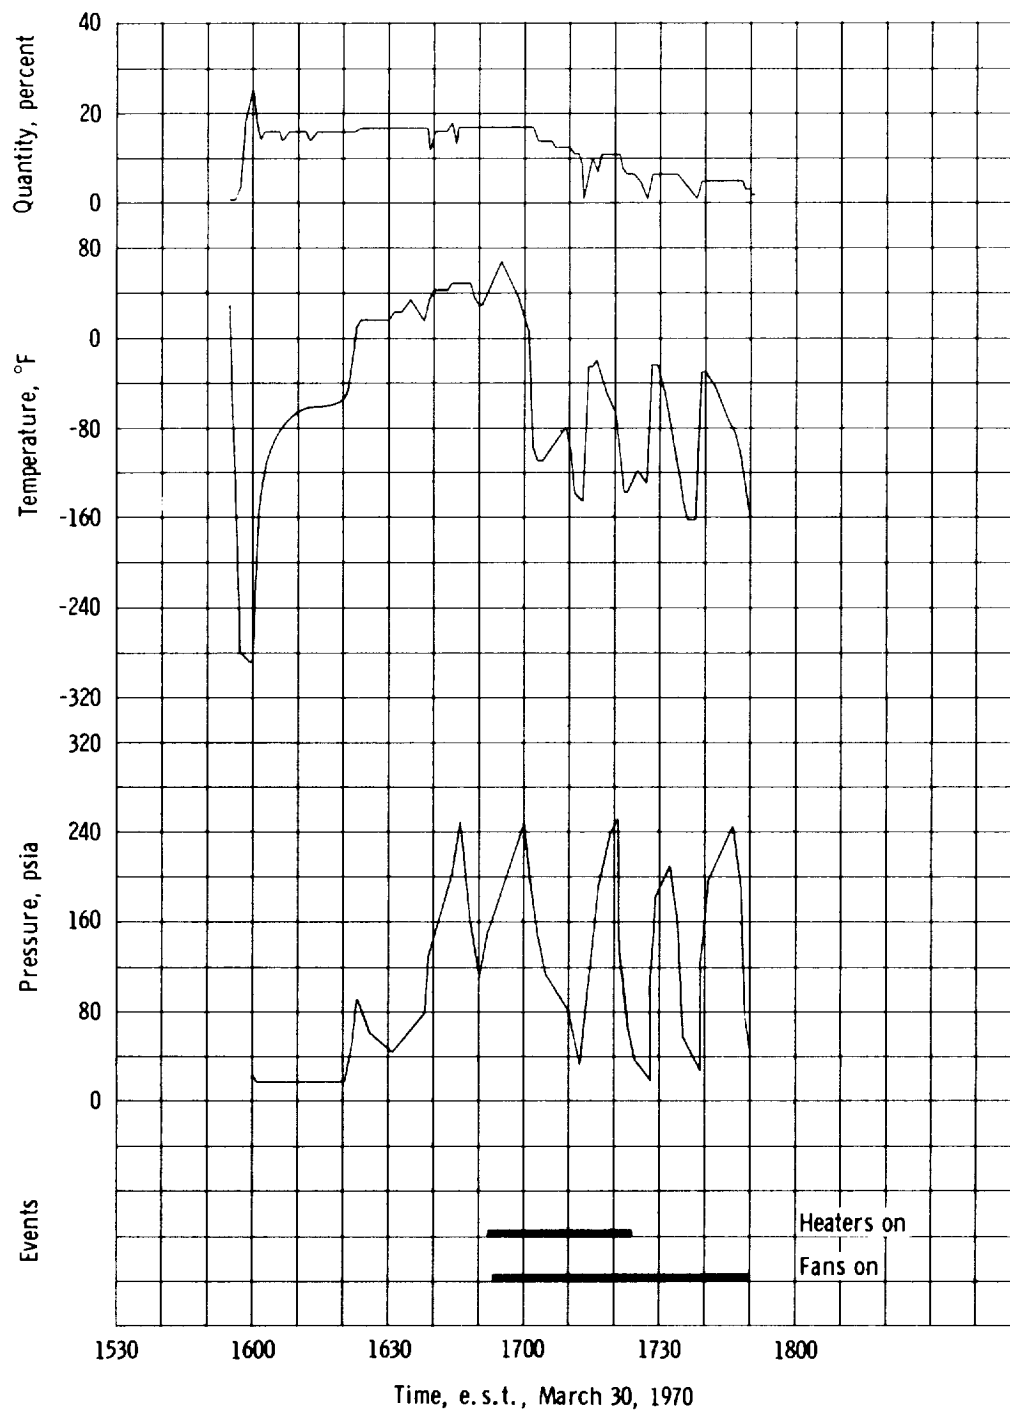
To verify this judgment and to assure countdown operability, both tanks were filled on March 30 to about 20 percent in approximately 2.5 minutes. Tank no. 1 detanked normally; tank no. 2 did not. Again the procedure of applying heat at maximum voltage and the cyclic application of gas pressure of approximately 250 psia and then venting was used. Five cycles were applied in a 1-1/4 hour period and tank no. 2 was emptied (fig. C4-63). The fan responses were observed to be normal and no indications of heater cycling were observed.

Figure C4-63.- Oxygen detanking using pressure cycles and tank heaters.

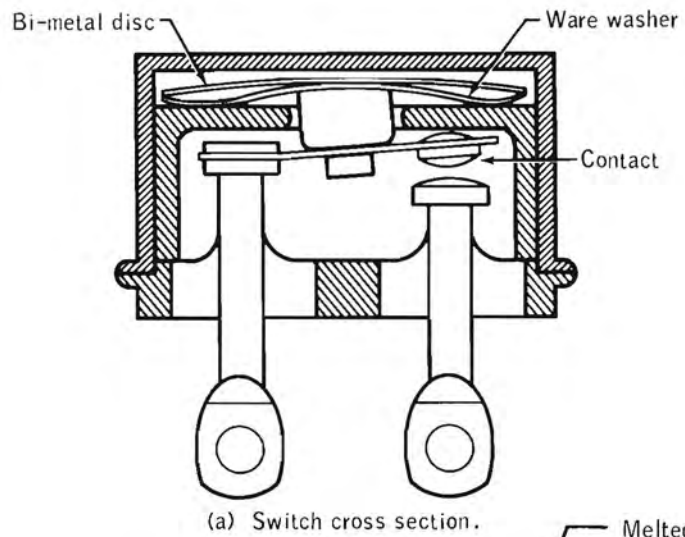
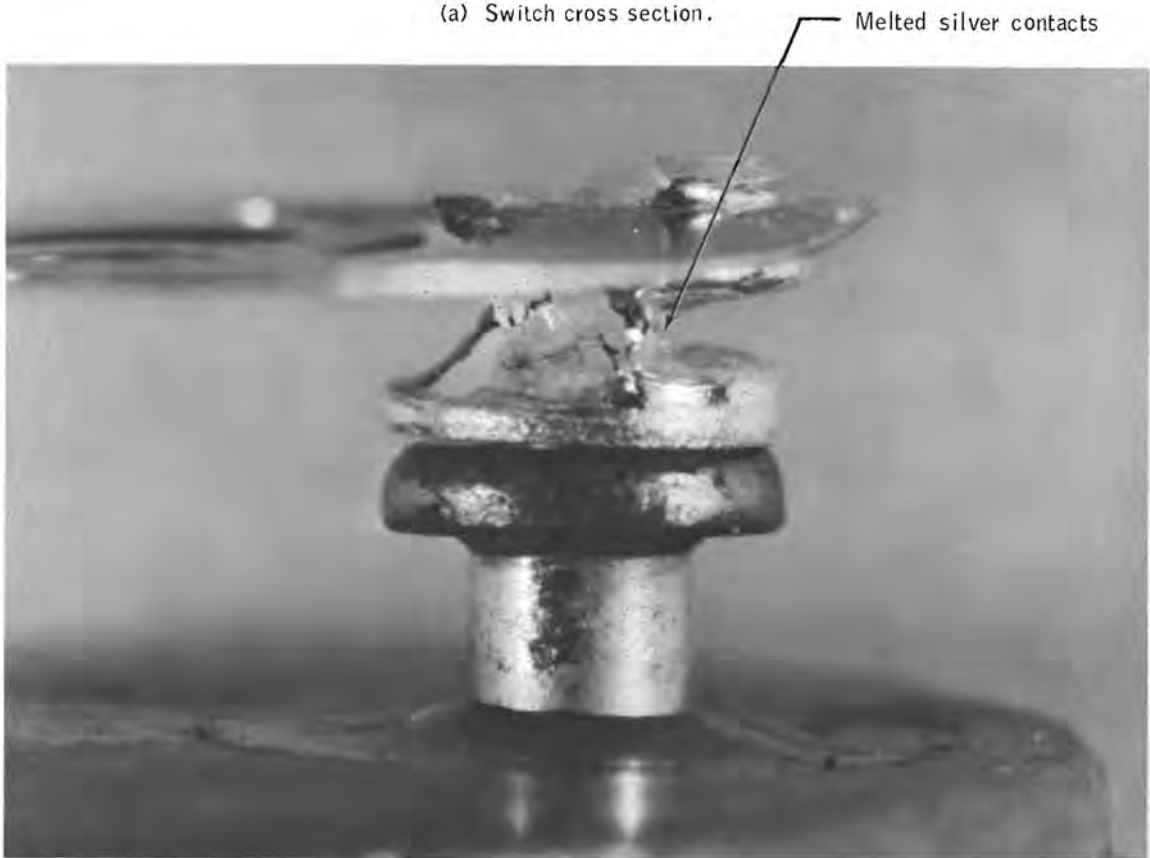
The test was started and after a few cycles in this mode the previously nonfunctioning (open) thermostat started indicating normal function. At this time it was decided to revert to the originally intended test configuration, i.e., the thermostats directly controlling the heaters. Data from that point on indicated that the thermostats were not cycling the heaters. The heater tube temperature data looked just like the nonthermostat test run. The test terminated at this point and the thermostats were removed and X-rayed. The X-rays indicated that the contact gap was bridged. One thermostat had its case carefully removed to examine the conditions of the contacts (fig. C4-67).

At no time during standard checkout, prelaunch, and launch operations are these thermostats required to interrupt the 65 V dc ground power supply current. As far as could be determined, the special detanking operation was the only time that any thermostats were ever called upon to interrupt this load.

Figure C4-67.- Thermostat configuration and welded contacts.

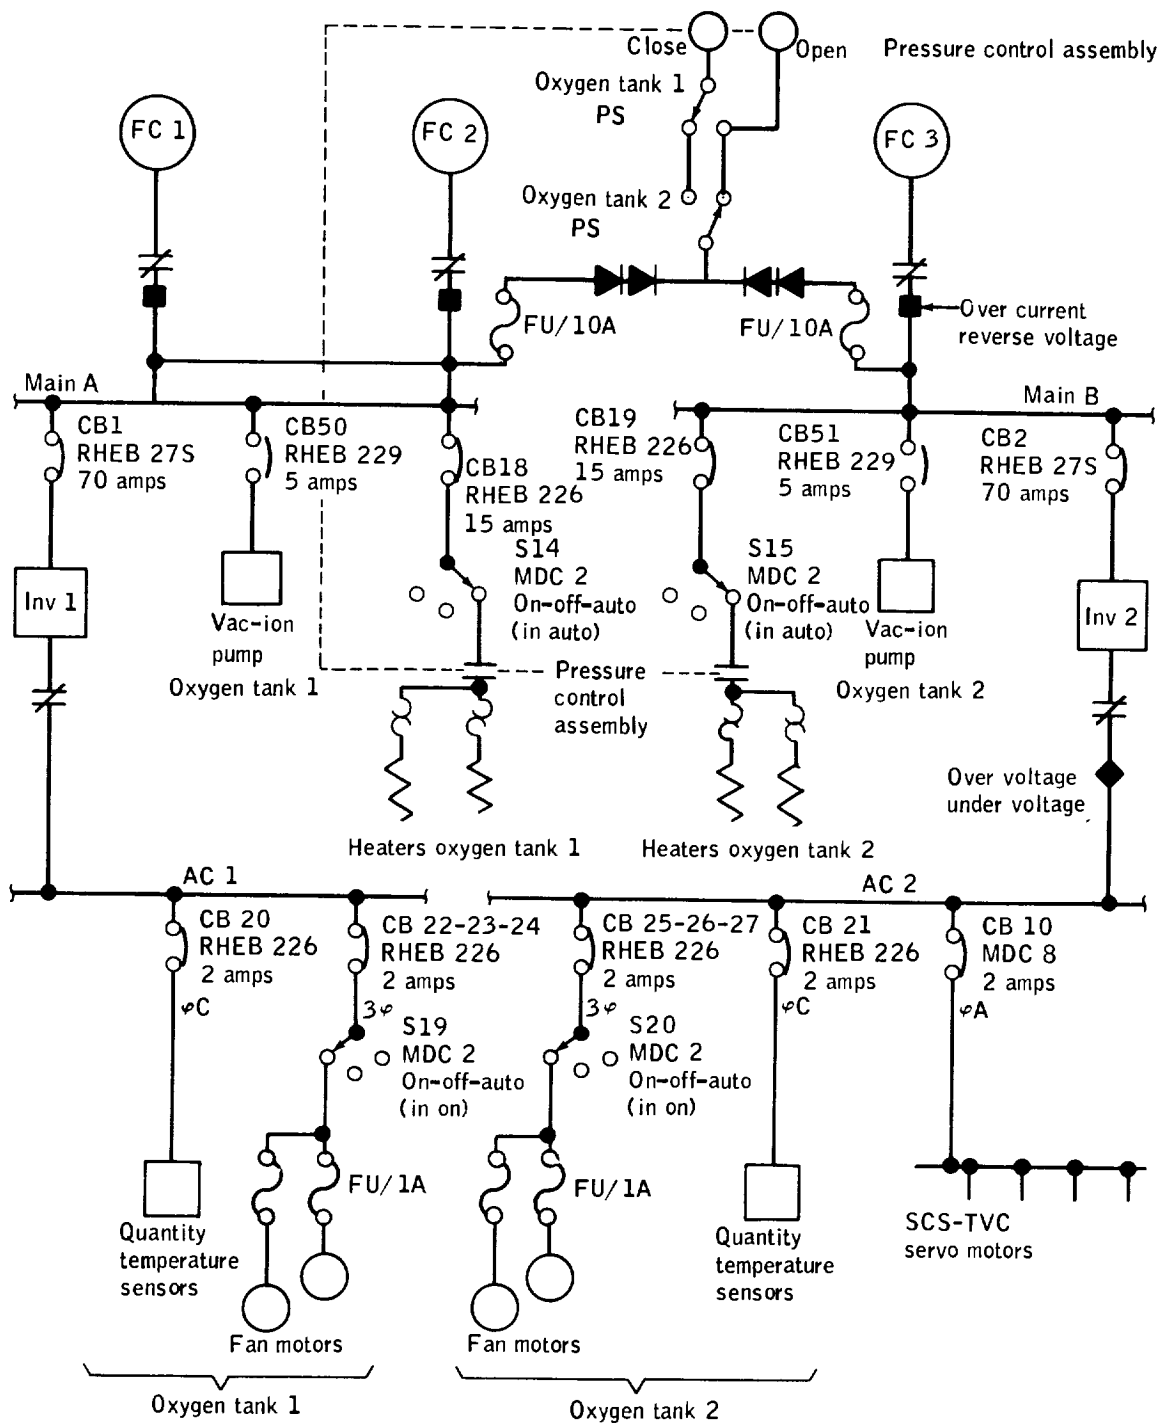
Figure D3-5.- Electrical schematic of relevant portions of electrical power system at 55:53:21.

The electrical power system, in general, provides multiple power busses with switching options for selecting an operating configuration. At 55:53:21, the electrical system was configured in accordance with reference 1, as shown in figure D3-5, with fuel cells 1 and 2 connected to main bus A and fuel cell 3 connected to main bus B. Inverter 1 was connected to main bus A and powering ac bus 1. Inverter 2 was connected to main bus B and powering ac bus 2. Inverter 3 was not connected. Battery busses A and B were not connected to main bus A or B. The switches controlling heater operation for both oxygen tanks were in the "automatic" position, controlling heater operation through the pressure control assembly. Pressures in the oxygen tanks were at levels which did not demand operation of the heaters. Temperature and quantity sensors on oxygen tank no. 2 were energized from ac bus 2. The quantity gage

had remained off-scale high from 46:40:06, indicating a probable short circuit either on the leads or the probe assembly. Operation of the fan motors in the oxygen tanks was accomplished throughout the mission using manual control in lieu of the automatic operation afforded by the logic of the pressure control assembly. A routine operation of the fans was requested by the ground at 55:52:58 and acknowledged by the crew at 55:53:06. Energizing of the fans in oxygen tank no. 1 is confirmed by a drop in voltage of ac bus 1 and an increase in total fuel cell current at 55:53:18. Energizing of the fans in oxygen tank no. 2 is confirmed by a drop in voltage of ac bus 2 and an increase in total fuel cell current at 55:53:20. Data substantiating operation and operation times are presented in Appendix B.

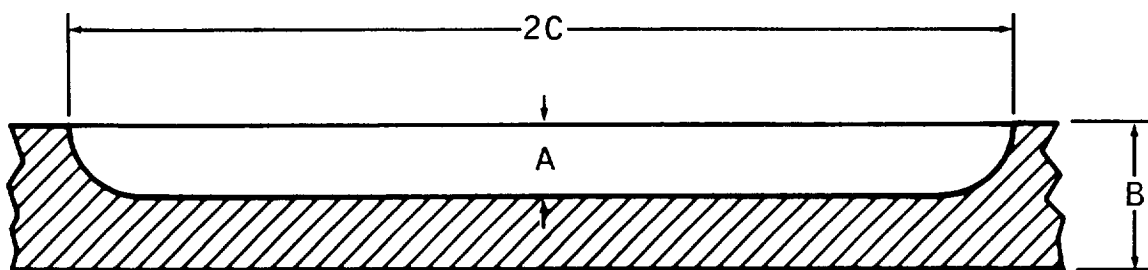
Figure D3-9.- Ligament model for ductile fracture of pressure vessel.

The proof test is the last, and should be the best, flaw detection procedure applied to a pressure vessel. Ideally, the proof test should cause failure if there are any flaws present that could grow to a critical size during subsequent pressurization. For the oxygen tanks in question, a fracture mechanics analysis cannot be made to assess the adequacy of the proof test because of the high toughness of the material and the thin sections used. These factors in themselves, of course, contribute to the confidence that can be placed in the integrity of the pressure vessel and, as discussed in the previous section, essentially rule out the possibility of brittle failure. However, it is worthwhile to estimate the effectiveness of the proof test in identifying those pressure vessels which might develop leaks during pressure cycles subsequent to proof. The failure model proposed considers the plastic instability fracture of a ligament of material produced by incomplete fusion during electron beam welding. The main features of this model are illustrated in figure D3-9. It essentially represents a long flaw in the tank wall at the

equatorial weld. It is postulated that the ligament will fail when its stress reaches the tensile strength of the material. Calculations show that the ligament stress σ_l is related to the average wall stress

where F_{tu} is the ultimate tensile strength. Failure will occur by tearing of the ligament accompanied by rapid decompression of the tank. It should be appreciated that this is a rather crude model of ductile fracture, and will probably overestimate the failure stresses in a spherical vessel. However, it should be useful in assessing the effectiveness of the proof tests in light of subsequent service, because of the very large margins between proof and operating pressures.

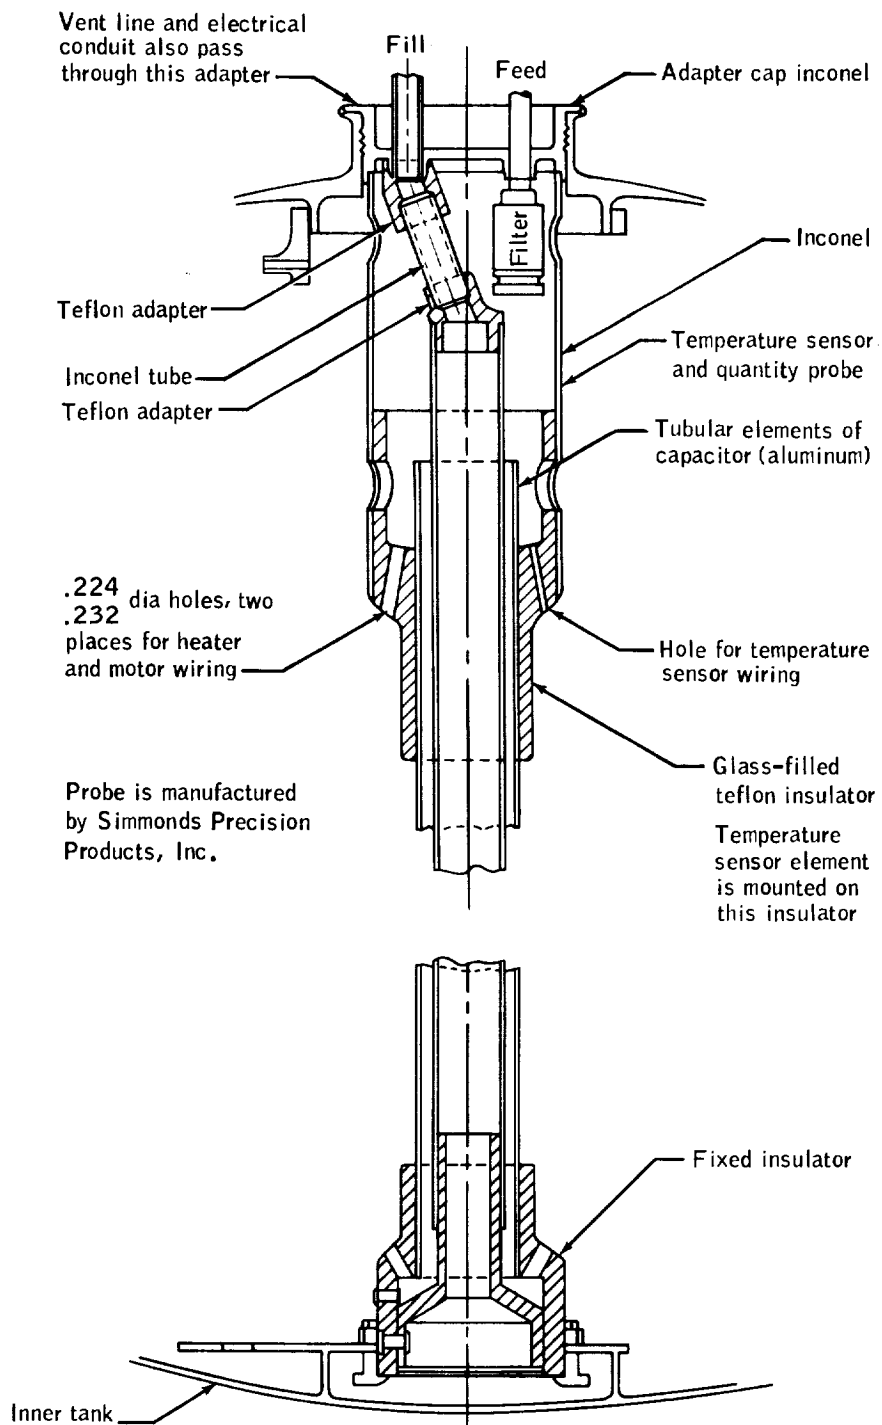
Figure D3-12.- Quantity gage.

The quantity gage capacitor (fig. D3-12) consists of two concentric aluminum tubes which are adequately mounted and supported. The inner tube of the capacitor constitutes the extension of the fill line. The outer tube is perforated to insure access of the oxygen to the space between the capacitor plates. The relative position of the two plates is maintained by insulating Teflon separators. Shorting of the capacitor at the plates within the tank requires bridging of the gap between the tubes by a conductive material. Shorting could also be induced by the contact of bare lead wires resulting from insulation damage. The power input to the quantity gage is regulated and limited by the high impedance source of the signal conditioner. The spark that could be

generated is at the 7- to 10-millijoule level. The evidence provided by the data can be construed to indicate that the effects of the probe failure during flight were limited to data loss.

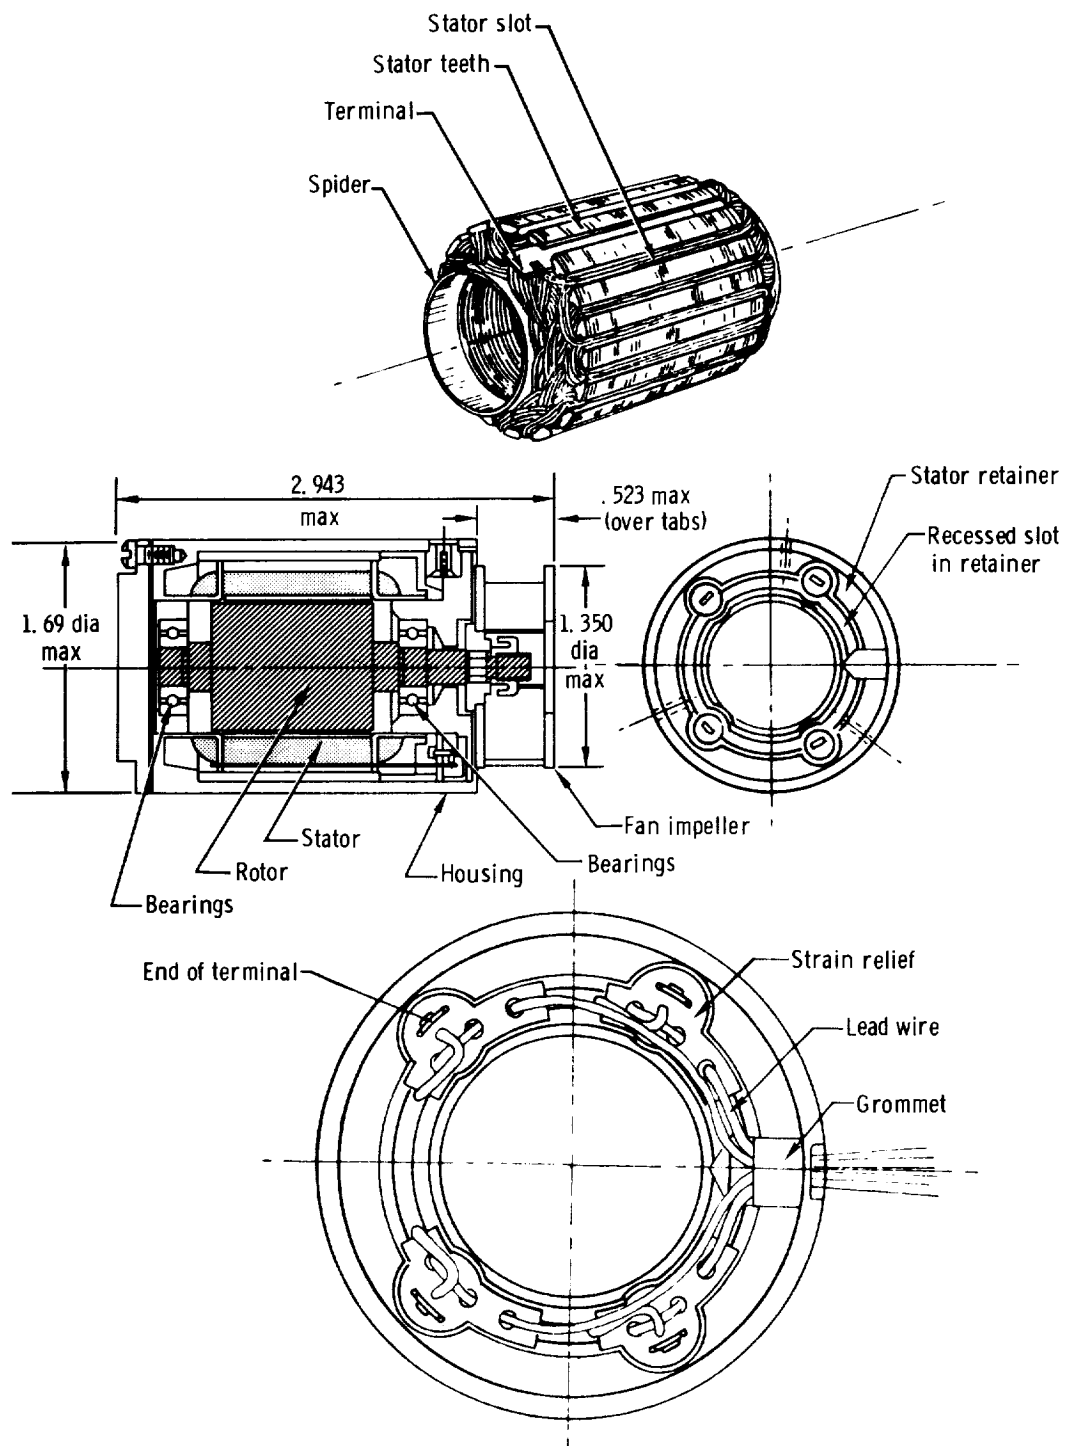
Figure D3-15.- Oxygen fan motor.

The two oxygen fan motors (fig. D3-15) are three-phase, four-wire, 200/115-volt, 400-hertz, miniature, open induction motors, driving centrifugal flow impellers. The minimum speed of the motors is 1800 revolutions per minute at a torque output of 0.9 ounce-inches. The motors are mounted at each end of the motor-heater support tube by a cantilevered attachment joined to the motor back plate. The motor clearance within the support tube wall is a nominal 0.01 inch. The stator windings and bearings of the motors are exposed to oxygen.

The stator windings are fabricated with number 36 American Wire Gage (AWG) wire, using a Teflon-coated ceramic insulation. The ceramic insulation is brittle and subject to breakage if proper tension is not used in fabricating windings or if sharp bends are made at the winding

end turns. Acceptance testing of the wire is conducted on the first 100 feet of each reel. The wire is considered acceptable if no more than 10 breaks in insulation are exhibited in the sample when pulled through mercury at 25 feet per minute. The rejection rate for stator winding faults for motors processed early in the production run was substantial. Improved yield was achieved only by rigid adherence to the winding tension process control used in fabricating the windings, proper assembly techniques, and frequent in-process dielectric testing. Phase-to-phase short circuits or shorted turns within a single phase are more likely than phase-to-ground faults. A limited amount of insulation is provided between windings and ground. Phase-to-phase insulation is limited to the end turns. Considerable improvement was accomplished in the acceptance rate of motors built after the fabrication control techniques were developed (Appendix C). No problem was exhibited in the testing of the two motors finally installed for flight in oxygen tank S/N XTAC0008.

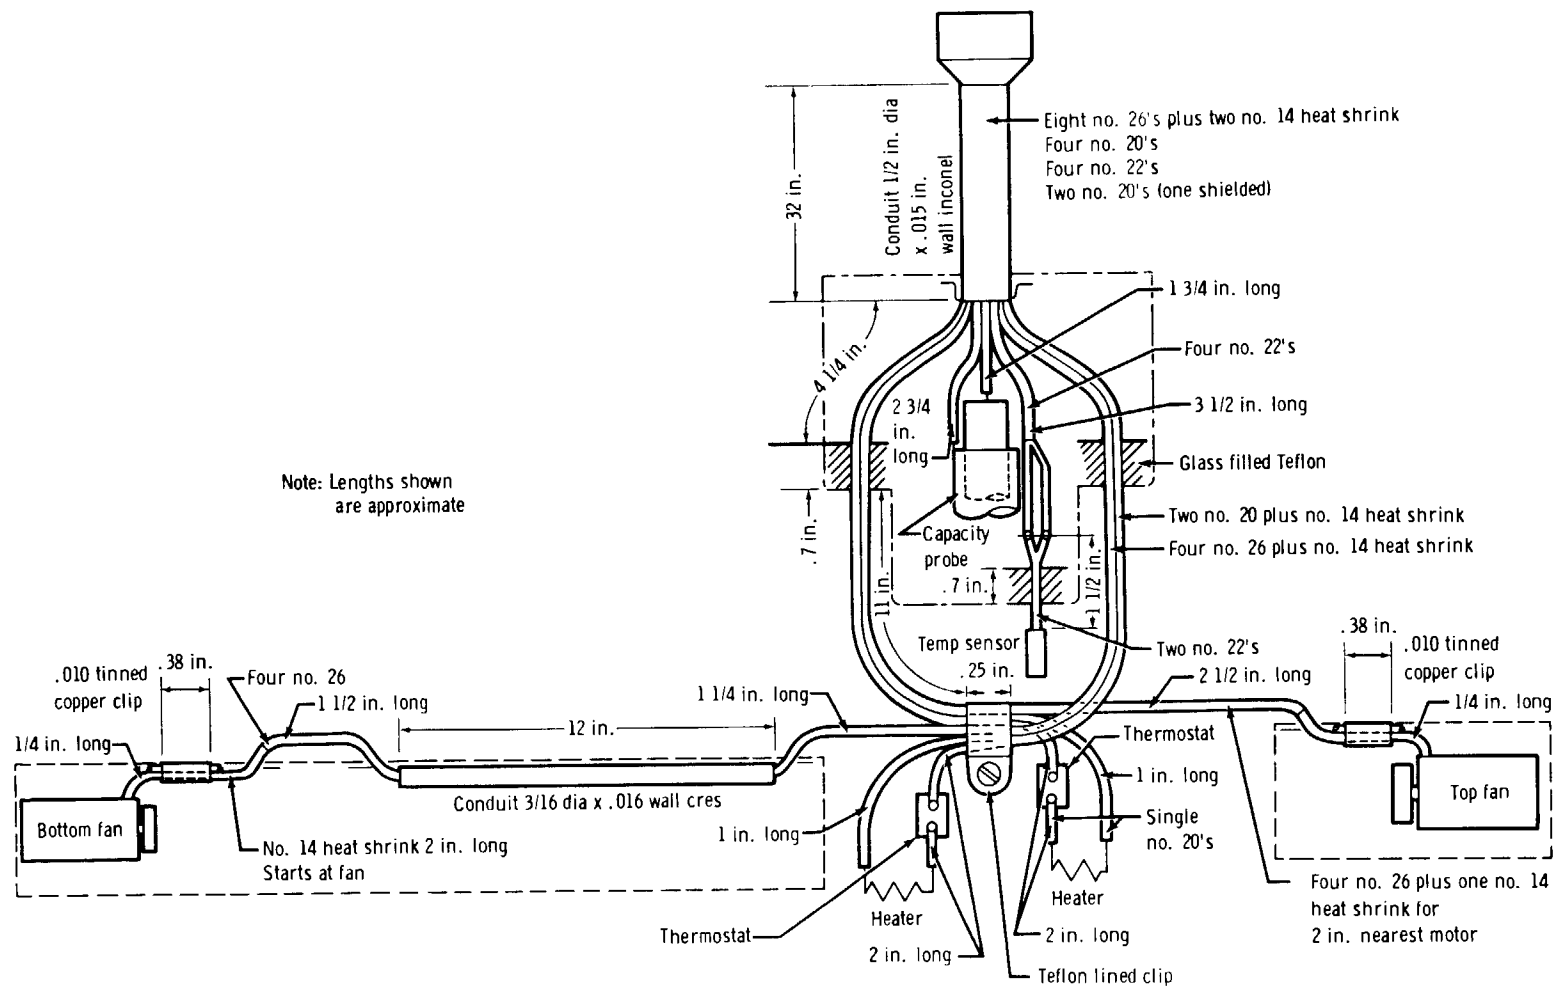
Figure D3-16.- Oxygen tank wiring distribution.

The mechanical design of the tank with respect to provisions for wiring is considered deficient. Damage to the wiring may be either insulation damage or conductor damage, portions of which cannot be inspected or adequately tested during or after assembly.

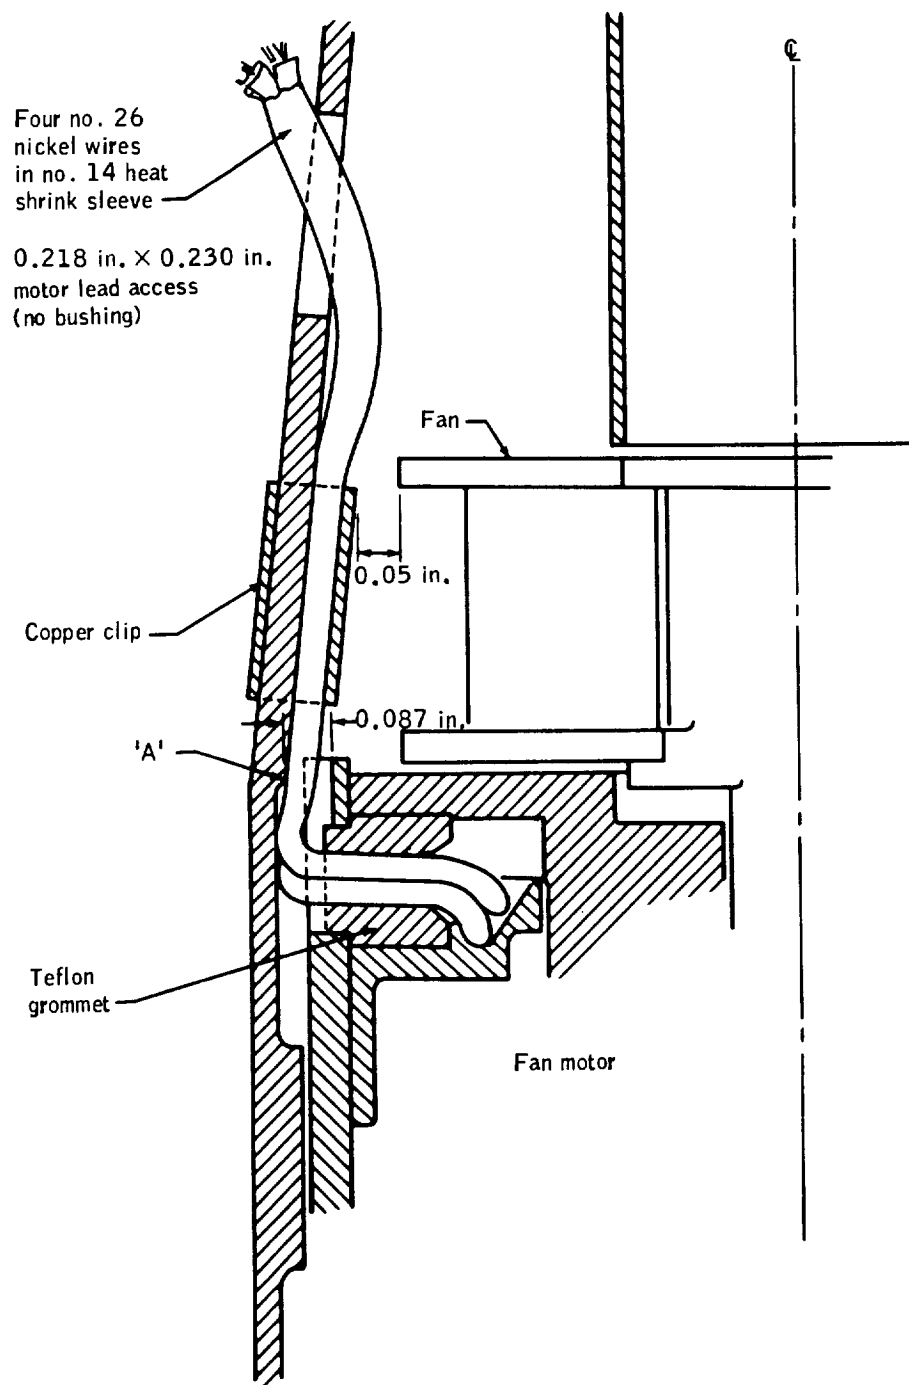
Figure D3-17.- Typical wire routing for fan motor (four times full size).

During assembly of the tank, three bundles of six wires each are sequentially pulled through the conduit. The first bundle, consisting of the two quantity gage wires and the four temperature sensor wires, is pulled through the conduit along with the pull wires for the other bundles. The second and third bundles each consist of one set of motor leads encased in 0.012-inch shrink-fit tubing and one set of heater leads. The pull wires have a break-strength of 65 pounds. Since the third bundle of wire must be forceably pulled through the conduit, damage to wires in this bundle or the others may result which may not be detectable without physical inspection. Physical inspection cannot be accomplished with this design.

The calculated break strength of a number 26 AWG nickel wire is 11 pounds and elongation of 28 percent can be experienced before break. If the number 26 AWG wires do not share the load associated with pulling the bundle through the conduit, damage to the wire(s) will result before the pull wire breaks. Stretching of the wire results in local neck-down of both the conductor and insulation. In subsequent operation of the circuit, the locally smaller gage conductor can produce local hot spots and progressive deterioration of the insulation.

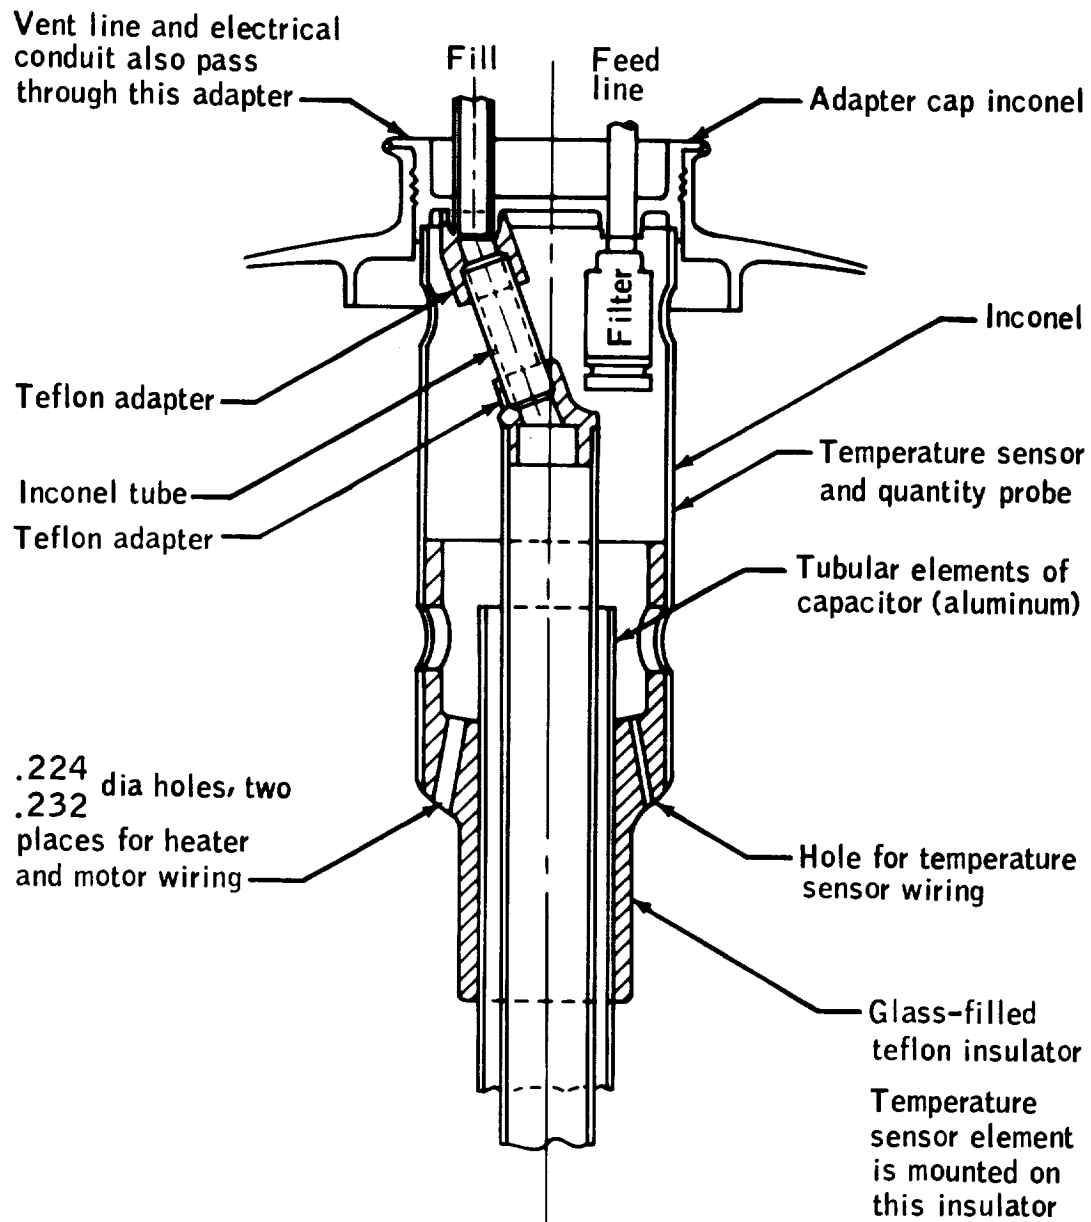
Figure D3-18.- Arrangement of head end of tank.

The head ends of the tank and the temperature sensor and quantity probe are shown in figure D3-18. One of the more significant features of the design is the arrangement of the connections in the fill line which routes the cryogenic fluid to the bottom of the tank, via the inner element of the quantity gage capacitor, and which permit the fluid to flow from the bottom of the tank during ground detanking. The manufacturing drawings of the elements of this connection, two Teflon adapters and an Inconel tube, allow a tolerance stack which is excessive. One combined worst case results in a connection which cannot reach from the fill tube connection in the tank head to the center element of the quantity gage capacitor. The other results in a connection length which prevents assembly of the probe to the adapter in the head of the tank. These are shown in figure D3-19. The tolerances on concentricity between the inner element of the capacitor and the outer shell of the probe are not known and are omitted from this figure. Inclusion would show an even worse situation than shown.

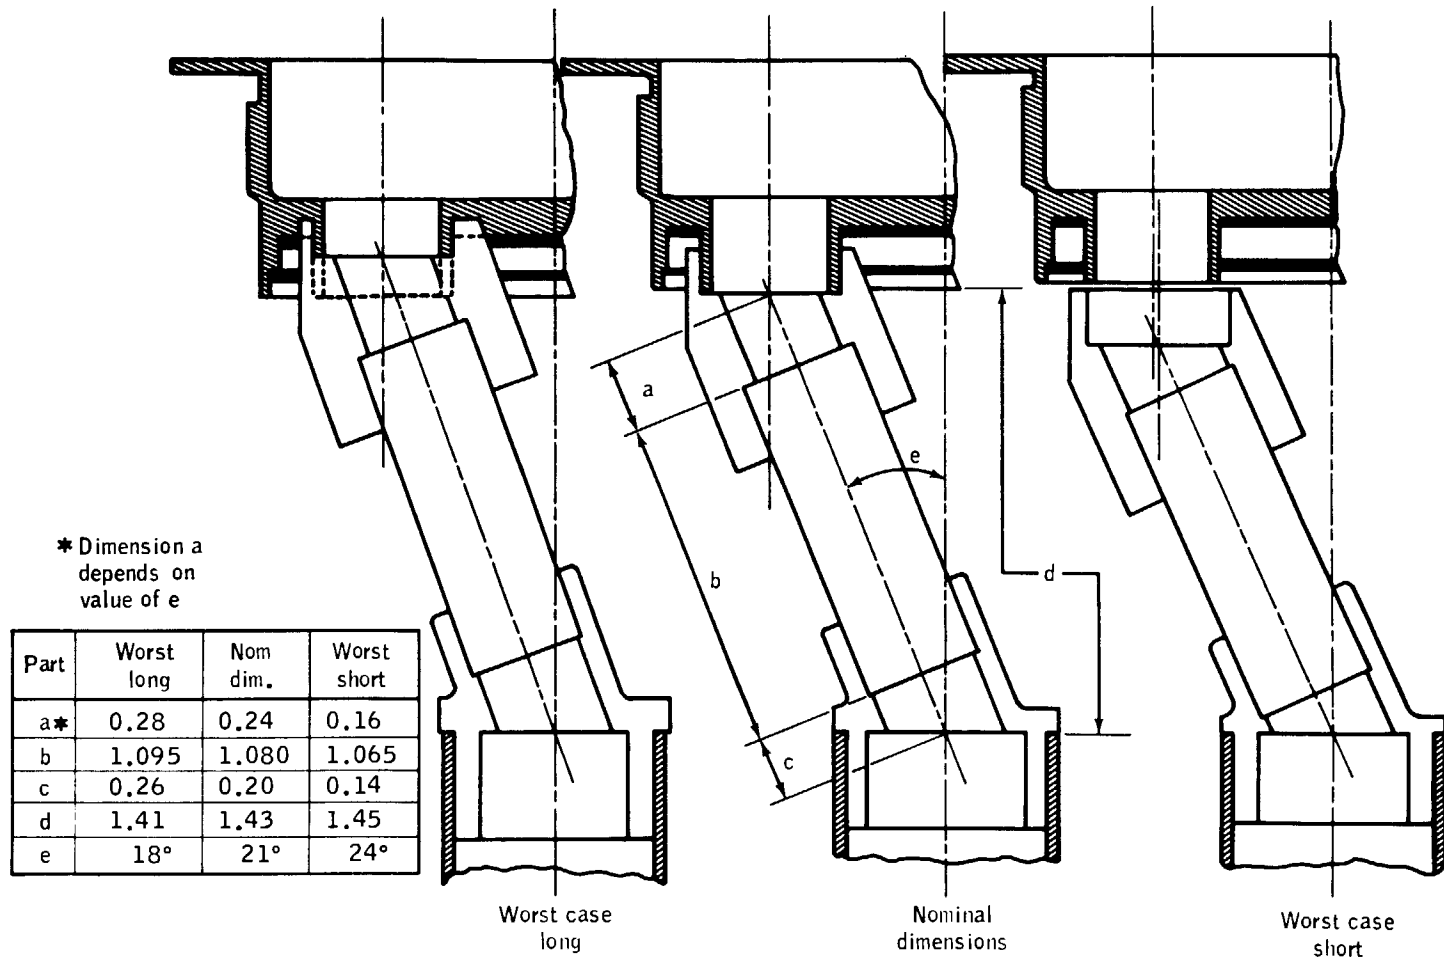
Figure D3-19.- Possible variations in fill line connection.

The experience with the oxygen tank no. 2 in Apollo 13 (apparently normal detanking at Beech, but normal detanking not possible at KSC) suggests that the components used in the fill line connection were close to a worst-case short situation. Tests conducted recently at Beech show that near normal detanking is possible when considerable leakage is present at the joints in the connection, and that a substantial displacement of the top Teflon adapter relative to the fill line in the tank adapter cap is necessary to reproduce the KSC situation.

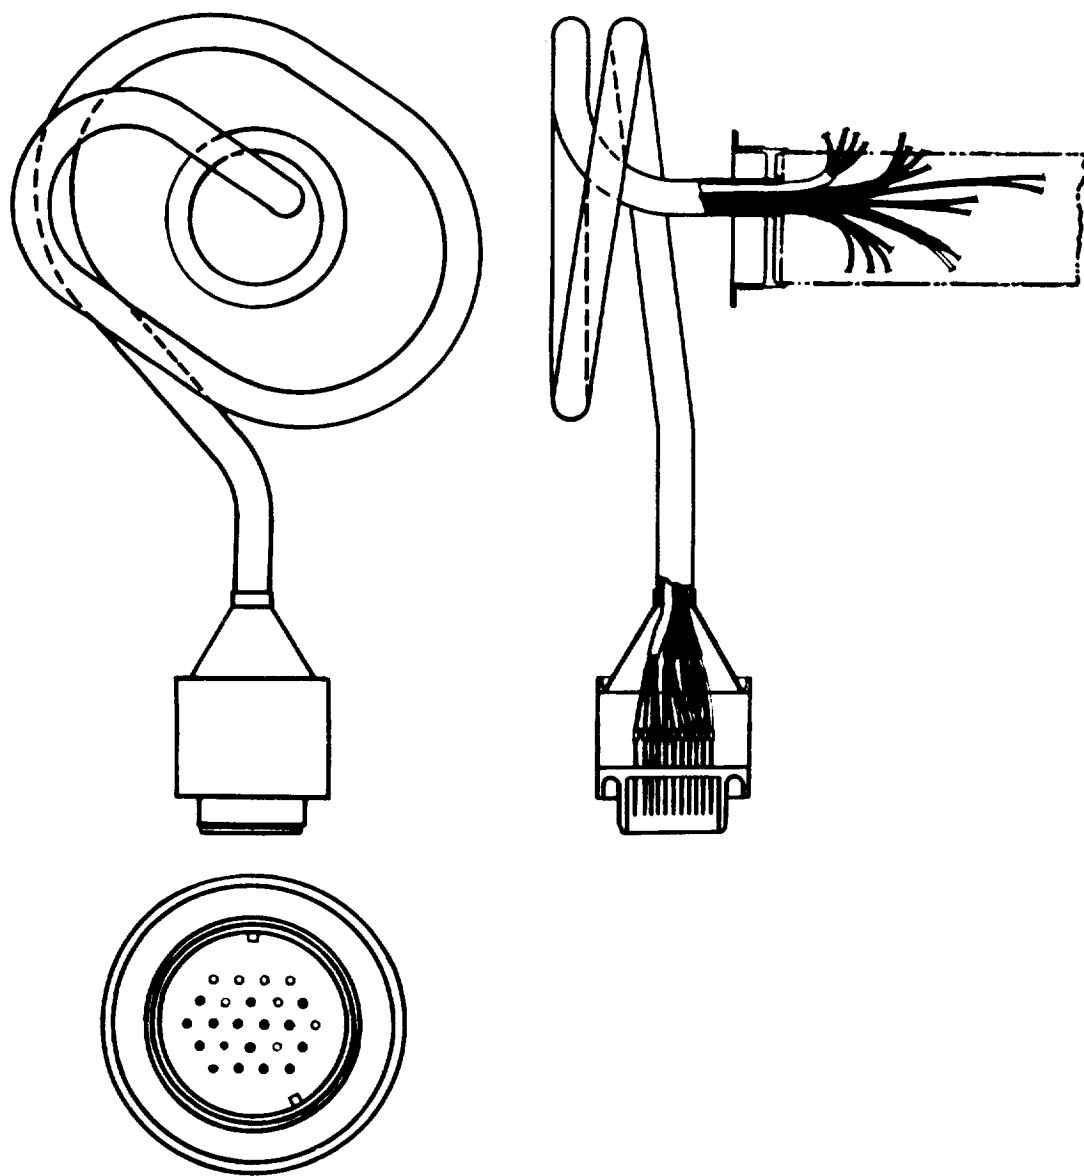
Figure D3-23.- Arrangement of electrical conduit.

A total of 18 wires pass through the electrical conduit, eight AWG no. 26's, four AWG no. 22's, and six AWG no. 20's. The conduit is shown in figure D3-23. At the start of the investigation some members of the Panel felt that the unorthodox detanking procedure used at KSC could have resulted in unacceptably high temperatures in this electrical conduit due to resistive heating of the heater wires. This possibility is discussed in a later section.

The design of this portion of the tank results in a configuration in which it is not possible to perform visual inspection of wiring after assembly. In consequence, the possibility of damage, in many cases undetectable by normal quality assurance procedures, is significant.
